FACILITY COMPLIANCE INSPECTION REPORT

Division of Waste Management Solid Waste Section

Date of Site Inspection: October 22, 2014

Inert Disposal - Stump Dump LCID Landfill
1017 Center Grove Church Road
Moncure, NC 27559

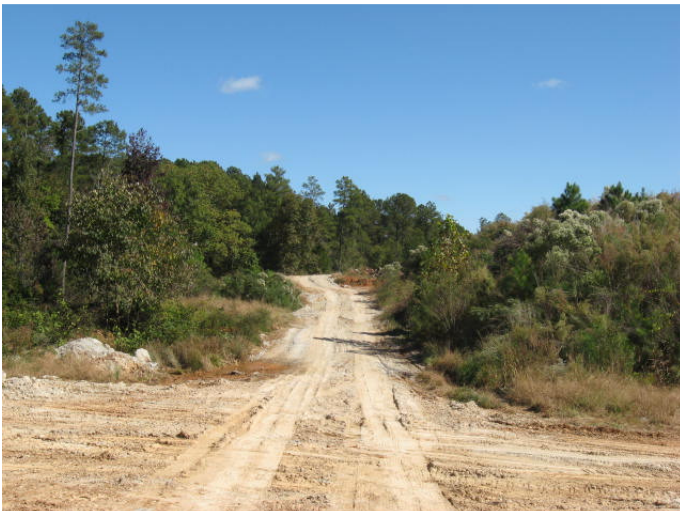
Entrance to LCID fill area

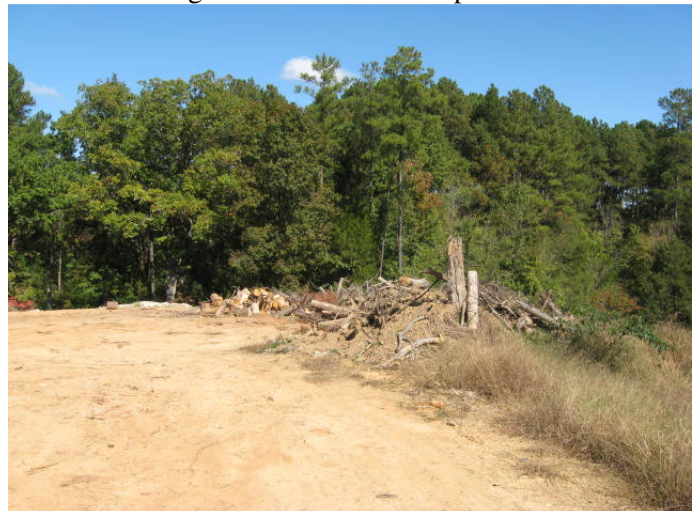
Material along rear external side slope – to cover w/soil

- b. Edge of waste markers will be installed around the LCID landfill at the edge of waste/toe of the external side slope.
 - c. Ensure that LCD is adequately covered with soil, monthly.

13. Side slopes should be graded and covered with soil such that a 3:1 slope ratio is obtained or a ratio of which no indication of erosion or runoff is observed.
